WL-TR-94-2092

RECIRCULATING CAVITY CASING
TREATMENT FAILURE

FINAL REPORT FOR 04/01/93 - 02/01/94

AERO PROPULSION AND POWER DIRECTORATE
WRIGHT LABORATORY
AIR FORCE MATERIEL COMMAND
WRIGHT PATTERSON AFB OH 45433-7650

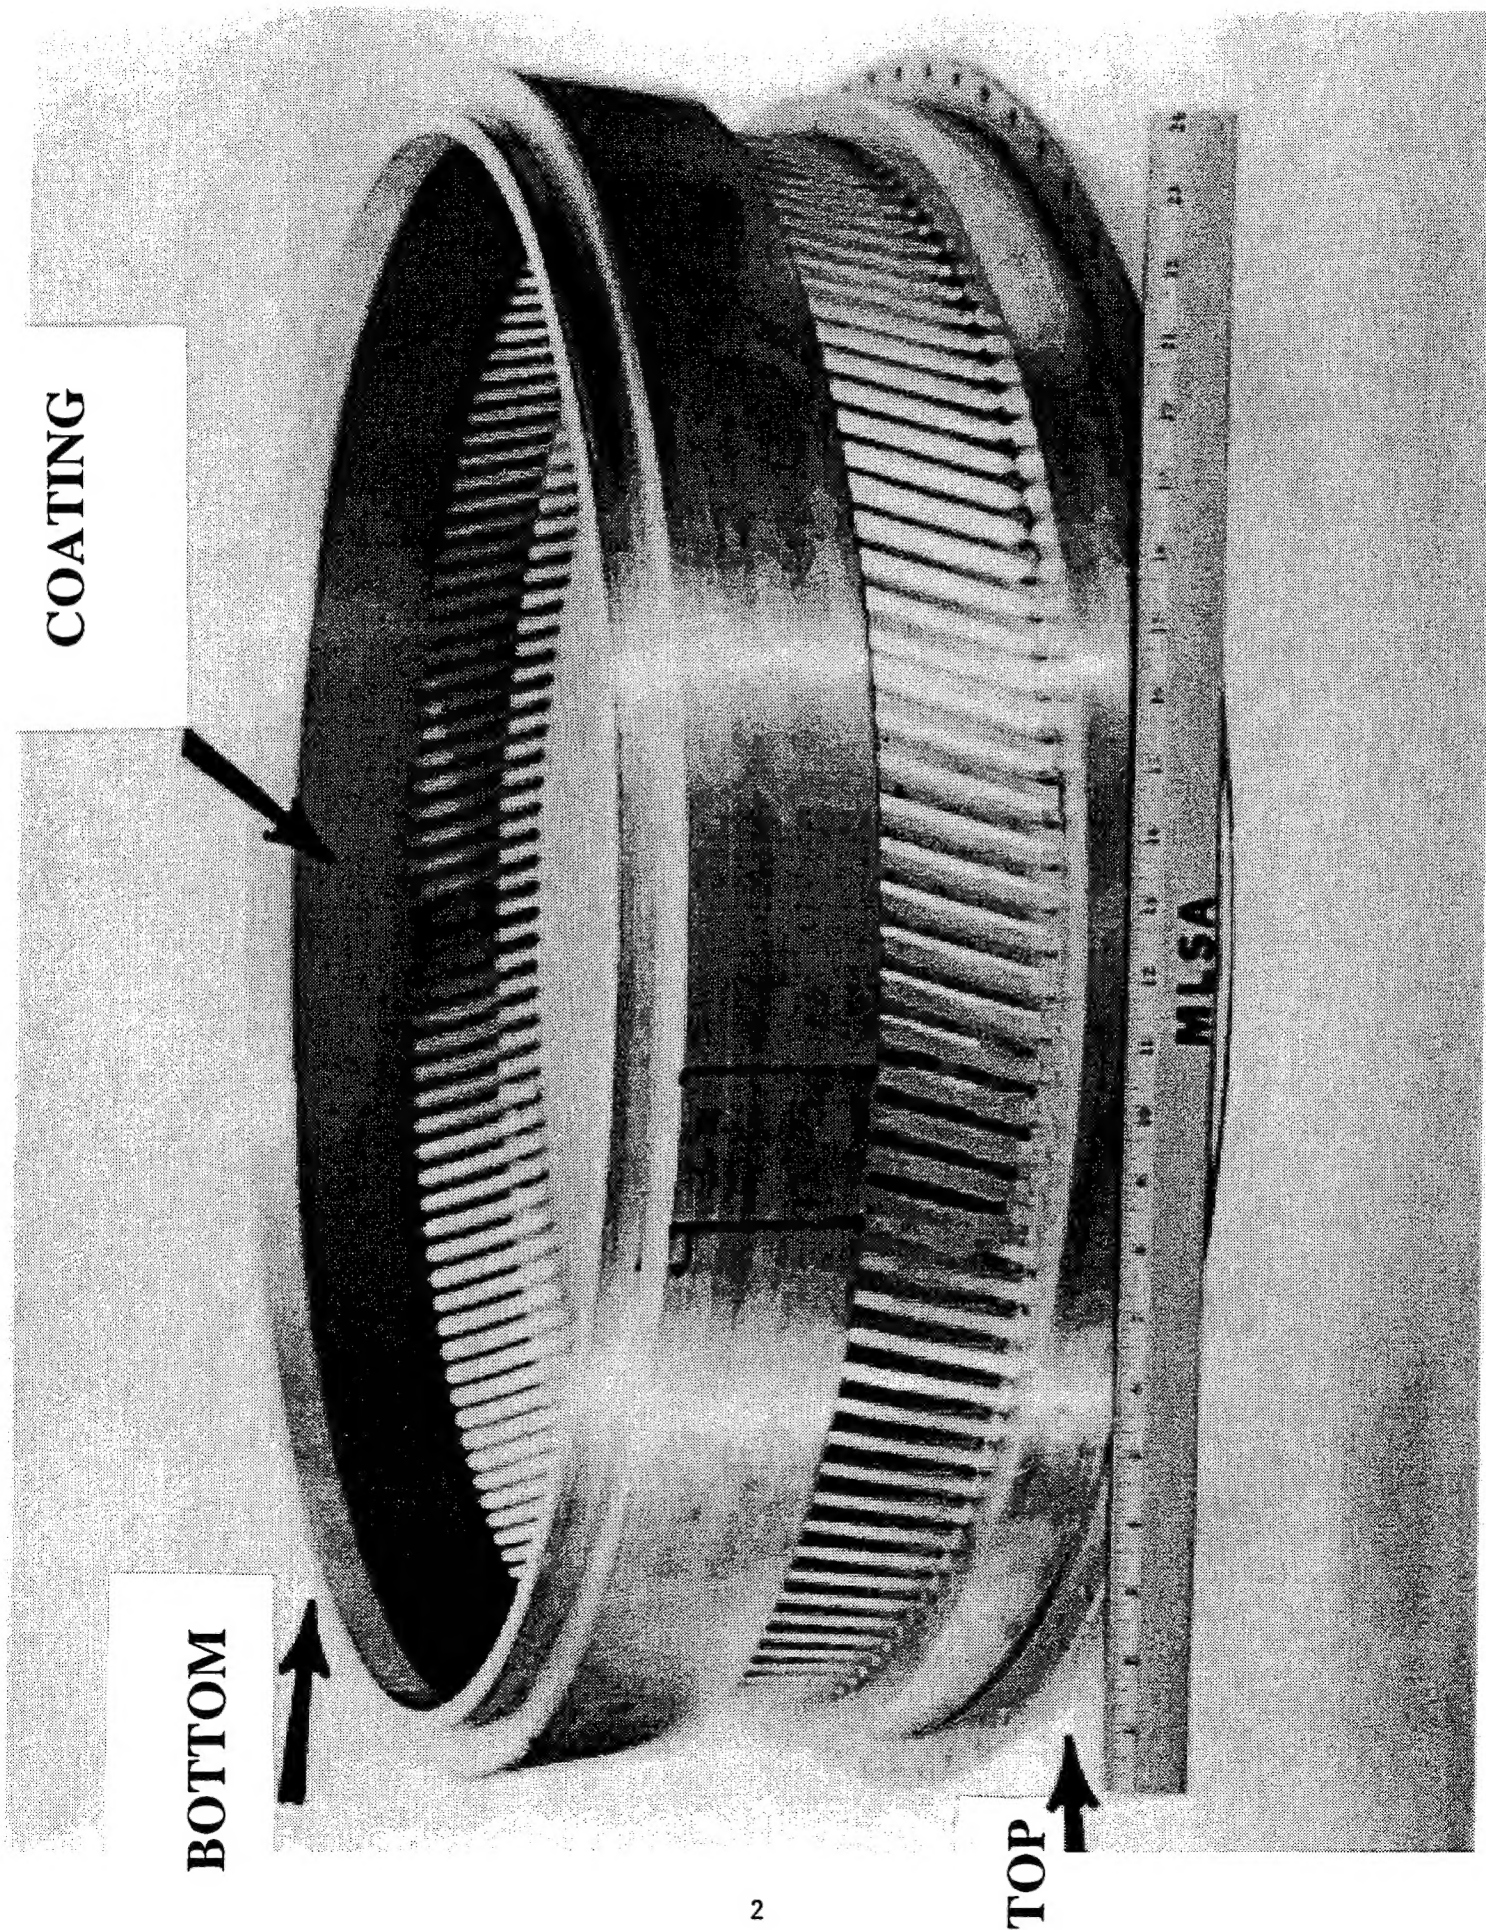
On 19 May 1993, the Test Article was boroscoped. The Recirculating Cavity Casing Treatment was found to be extremely discolored from the heat and some of the fingers were cracked. The casing treatment was removed and an overall view of the 6061-T6 aluminum alloy casing treatment can be seen in Figure 1.

Figure 1 Overall View of the 6061-T6 Recirculating Cavity Treatment

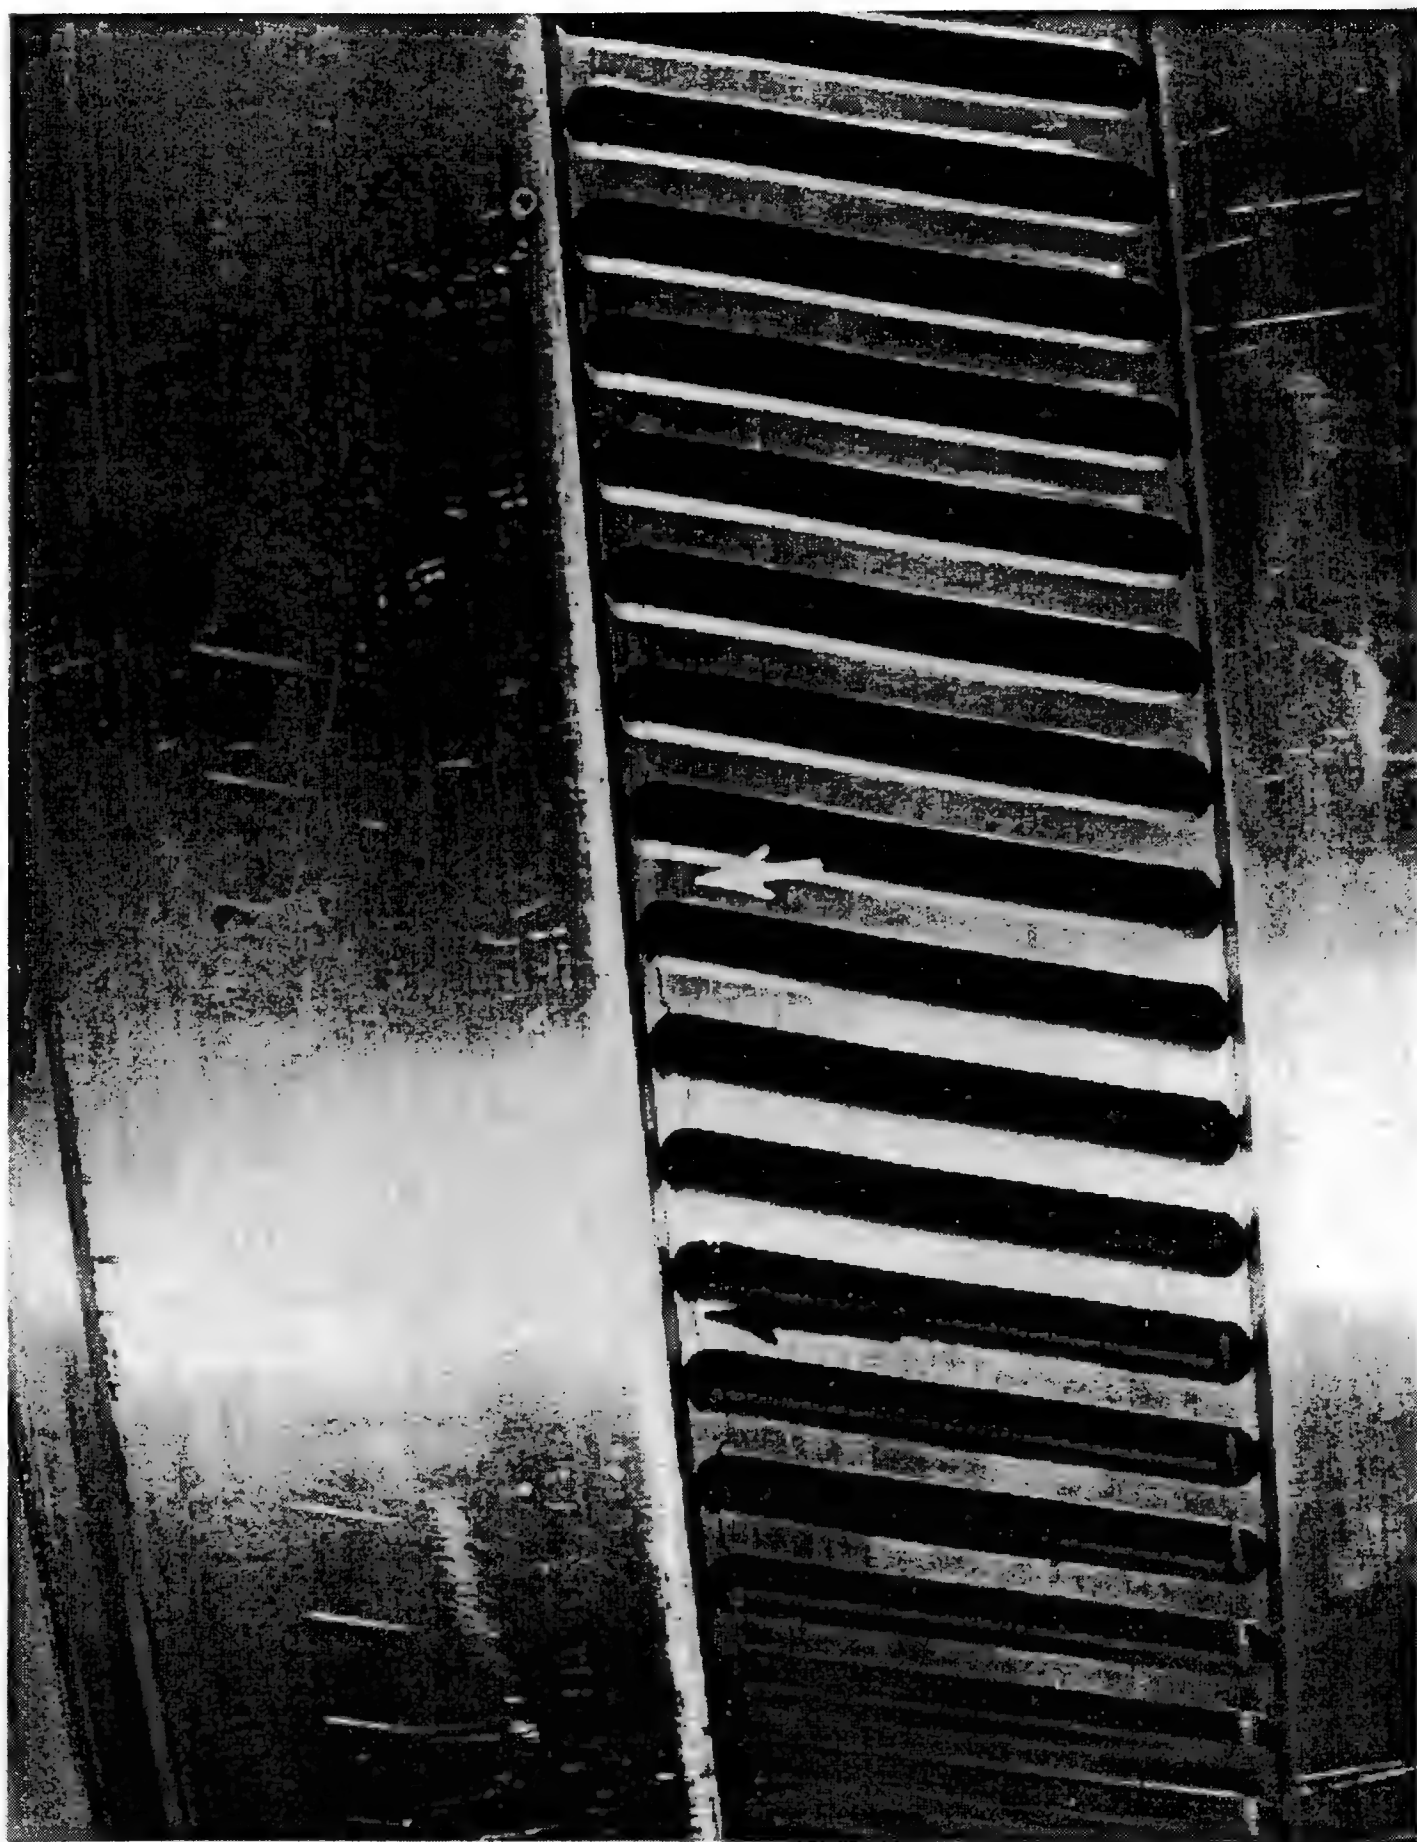
On 19 May 1993, the Test Article was boroscoped to find cracked fingers on the Recirculating Cavity Casing Treatment. See Figure 4. The casing treatment was then removed and failure analysis was started.

Figure 4 Photograph of the Cracked Fingers

After reviewing Figure 4, it can be seen only one end of the fingers developed cracks. This end is the downstream end of the casing seeing the hottest air flow. Cracks appear to originate from the two corners of the fingers, the corner being the intersection of the width and the thickness dimension of a finger. A close-up view of a crack in the finger can be seen in Figure 5. Scanning electron microscopy, Figure 6, determined these corner cracks to be due to mechanical fatigue. Scanning electron micrographs show fatigue striations indicative of mechanical fatigue, Figures 7 and 8.

Since fatigue cracking of the fingers is related to softening of the aluminum alloy, it is recommended 6061-T6 aluminum alloy not be used for this application.

Aluminum alloys 2219 and 2618 have better fatigue crack growth resistance under prolonged exposures between 300°F and 600°F and should be considered as alternate materials.

Although the suggested replacement aluminum alloys would work under the conditions specified and are lightweight, they are expensive and not readily available to a test program already on a tight time constraint. Since weight is not important in a ground test, the plain carbon steel 4041 will handle the rugged test environment, is available in stock at most metal distributors, and is easily machined.

It is also the recommendation of the paper to fully instrument the new casing treatment with thermocouples to analyze the effect of the elevated temperatures. Since the cracks occurred in the corners, it was suggested to increase the radius of the corners. This will also shorten the total machining time.

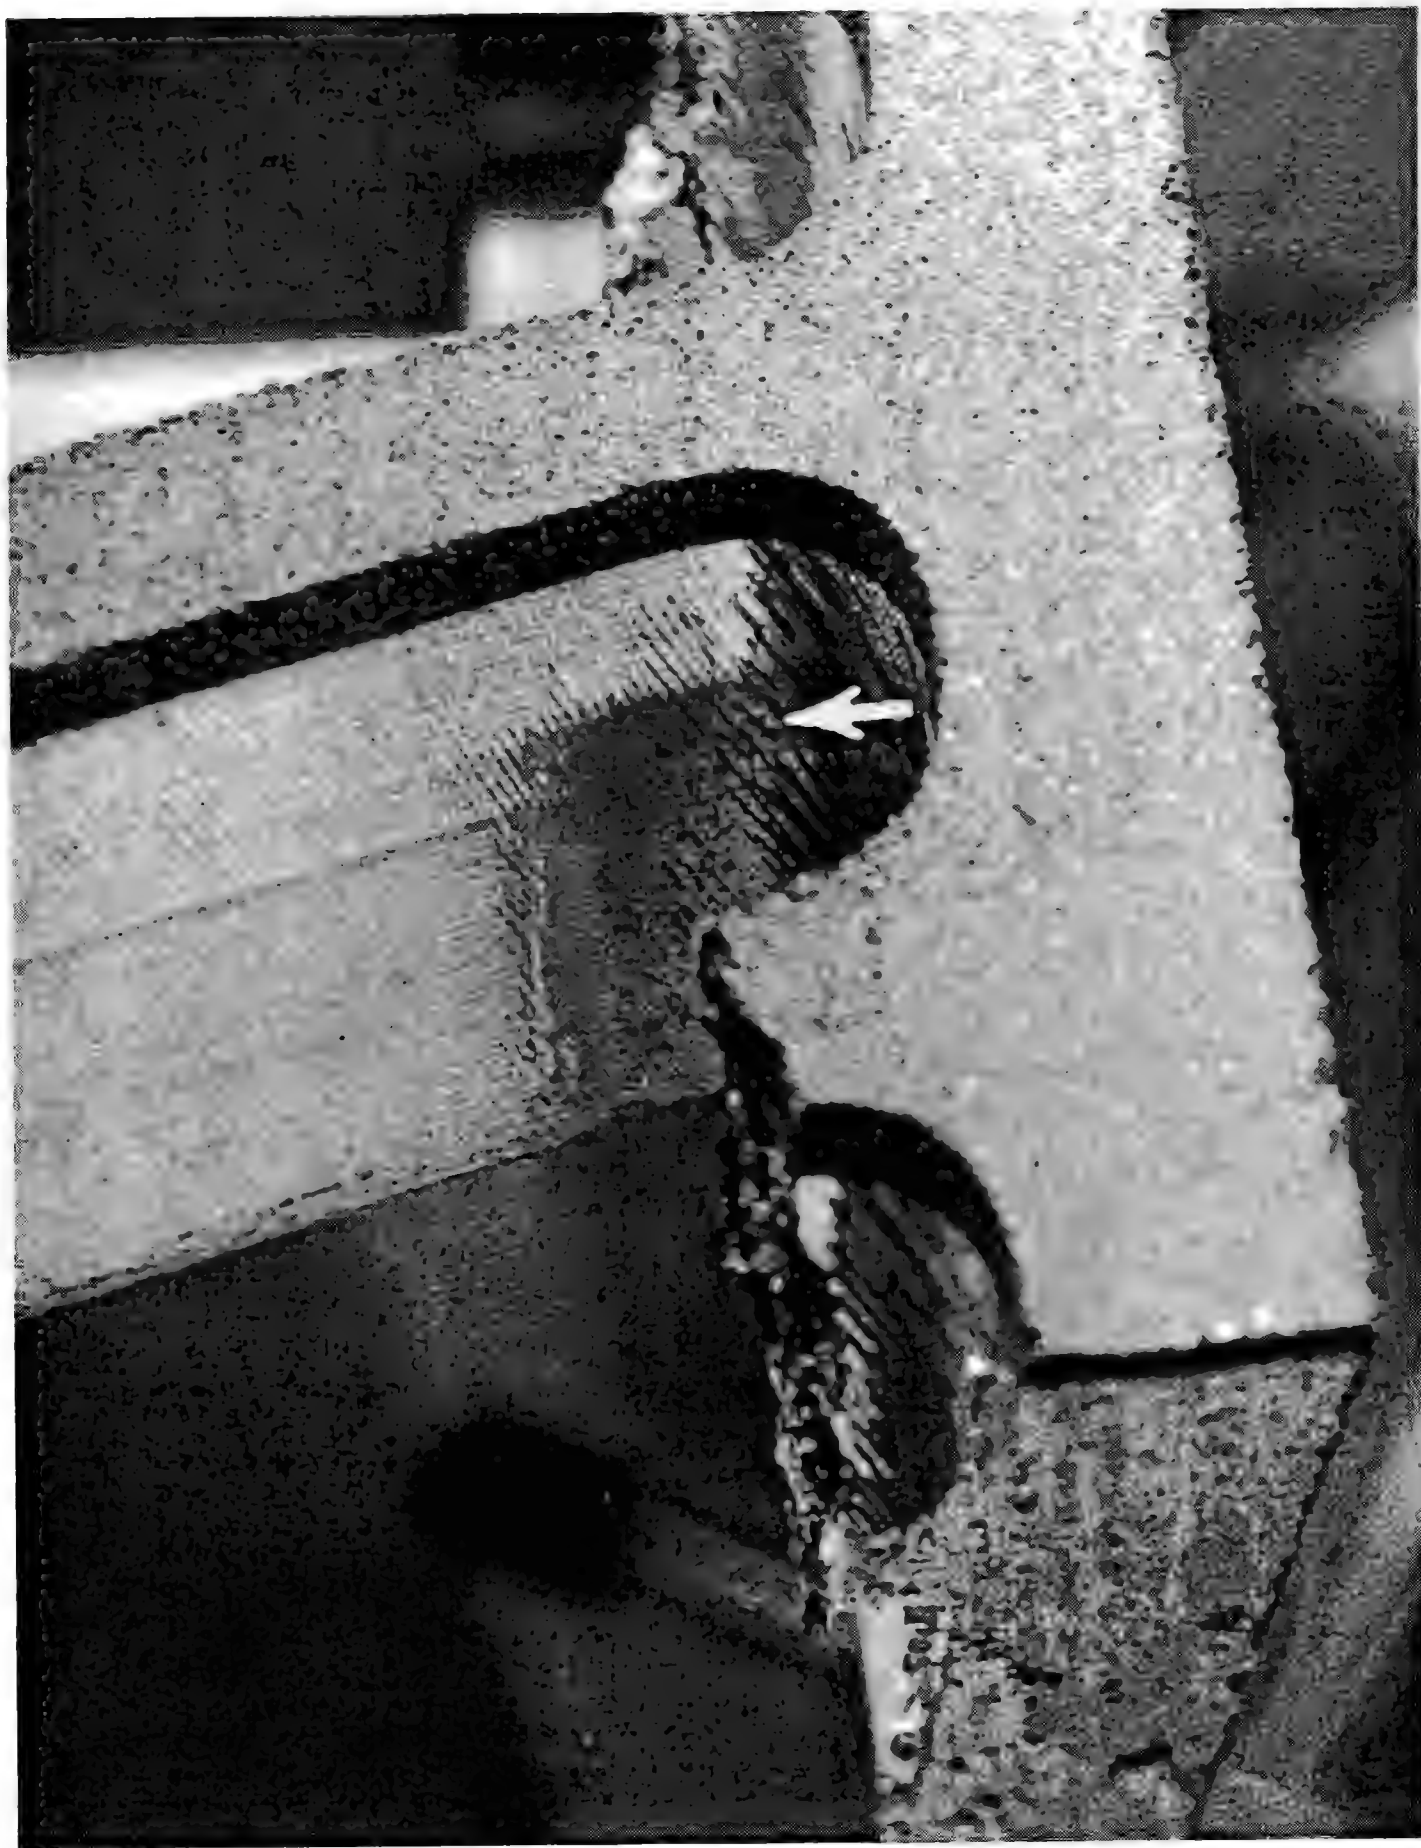
Hardness measurements on the cracked fingers showed substantial variation along the length of the finger. In the area where the fracture occurred, the hardness is Rockwell E (R_E) 67. In the middle of the finger, the hardness is R_E 63. The area at the bottom of the finger farthest from the fracture site is R_E 78. The minimum recommended hardness according to the American Society for Testing Materials Specification 2658 for 6061-T6 is R_E 85. The original design specifications did not call out a minimum desired R_E hardness value. The decreased hardness numbers are due to the extreme temperatures seen by the casing treatment.

Figure 5 Close-Up View of a Cracked Finger

All of the hardness numbers along the finger length were lower than the minimum recommended number of R_e 85 for 6061-T6. This would suggest the aluminum alloy softened due to exposure to high temperatures. Aluminum 6061-T6 will soften when exposed to temperatures greater than 300°F. Although the hardness in the middle portion of the finger is lowest, cracks did not originate in this region. The presence of a sharp radius at the junction and a low hardness caused the failure.

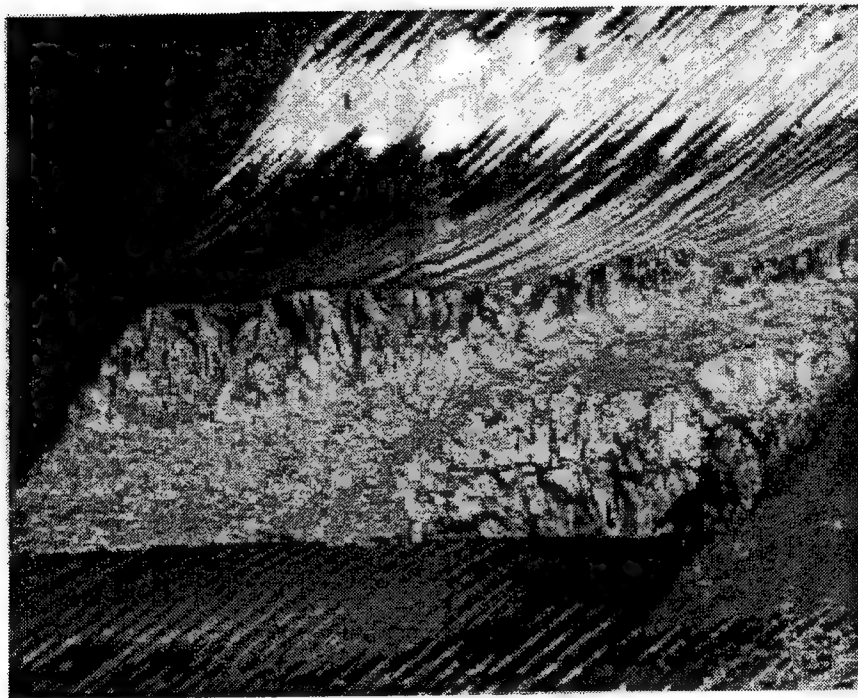
Figure 6 Optical Micorgraph Depicting Two Corner Cracks
Mag: 7.2X

Almost all of the cracked fingers exhibited corner cracks. The corner cracks were initiated and propagated by fatigue. Fatigue crack propagation data for 6061-T6 are available only for room temperature and 300°F temperatures. These data show at 300°F, fatigue crack growth rates are twice as fast as at room temperature. This suggested exposure to higher temperatures would only be further detrimental to crack propagation. Data on yield strength show 30 minutes exposure to 300°F decreases the yield strength from 42 Ksi to 36 Ksi. This would also imply reduced hardness.

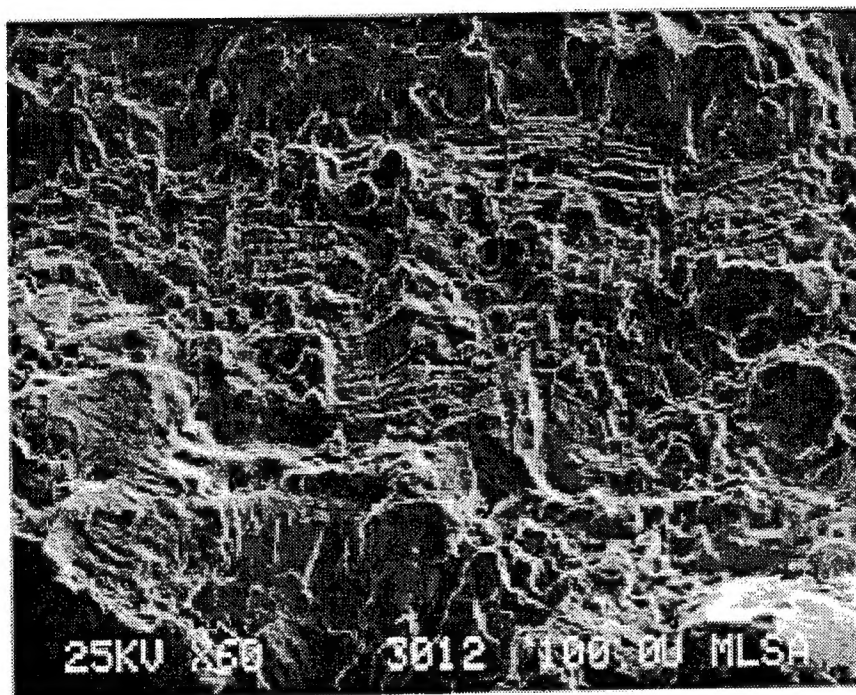
Figure 7 Scanning Electron Micrograph Fatigue Striations
Mag: 60X

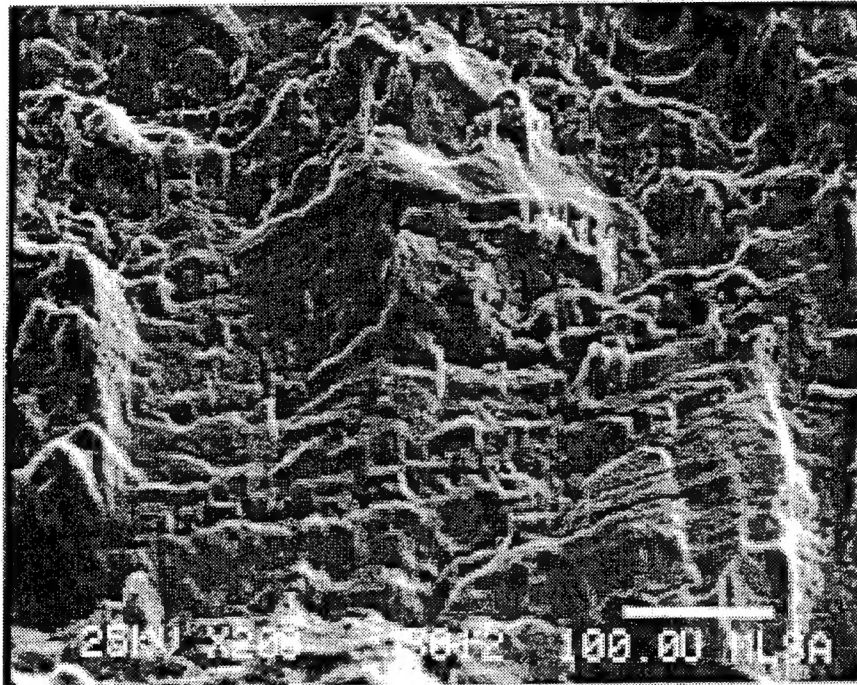
Figure 8 Higher Magnification View of Figure 7
Mag: 200X
